Derailment of Canadian Pacific Railway Freight Train 292-16 and Subsequent Release of Anhydrous Ammonia Near Minot, North Dakota January 18, 2002

Railroad Accident Report **NTSB/RAR-04/01**

**National
Transportation
Safety Board**
Washington, D.C.

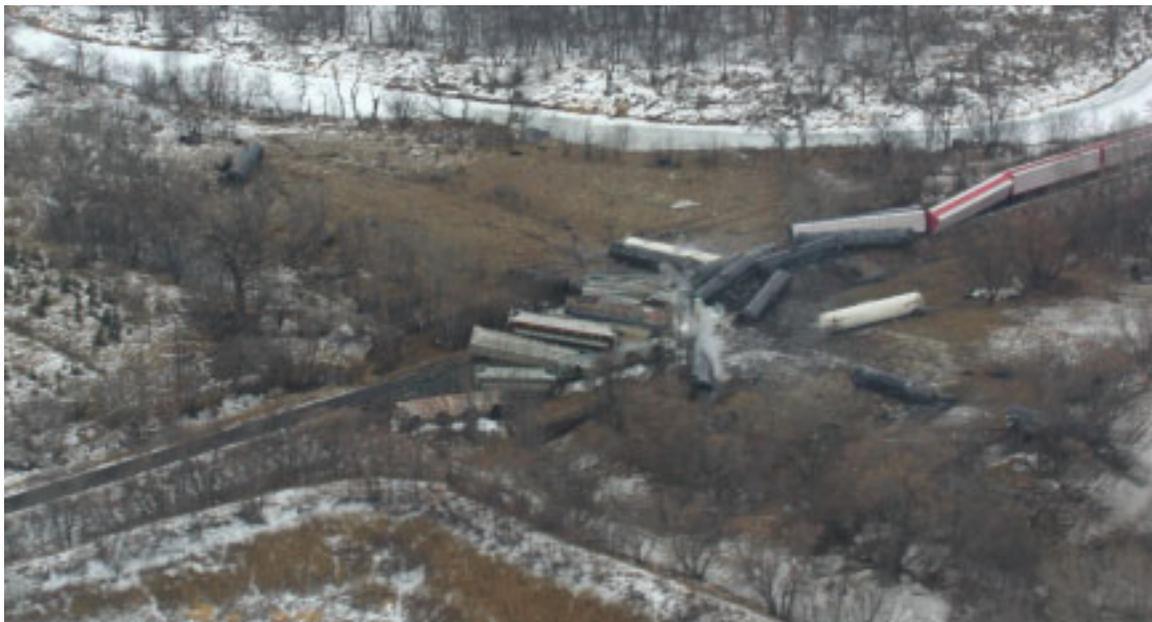
Figure 1. Looking southwest at accident scene.

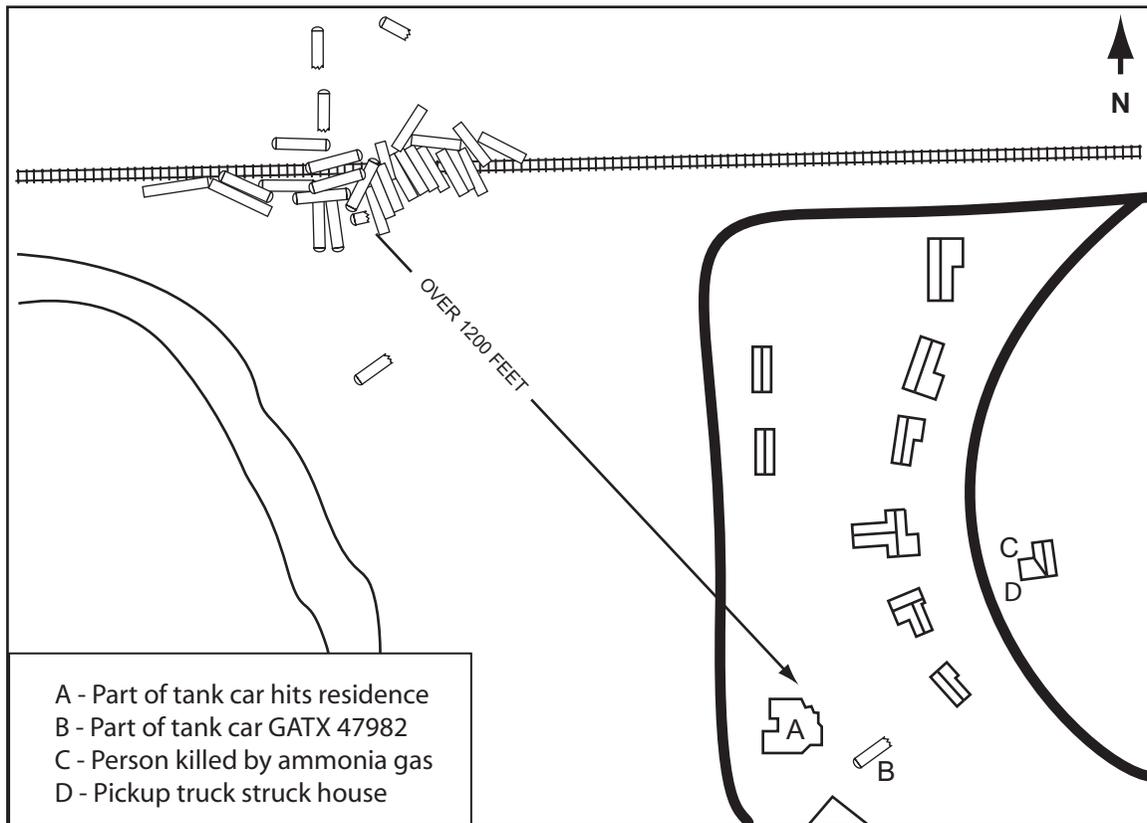
Figure 4. Detail of wreckage and Tierracita Vallejo neighborhood.

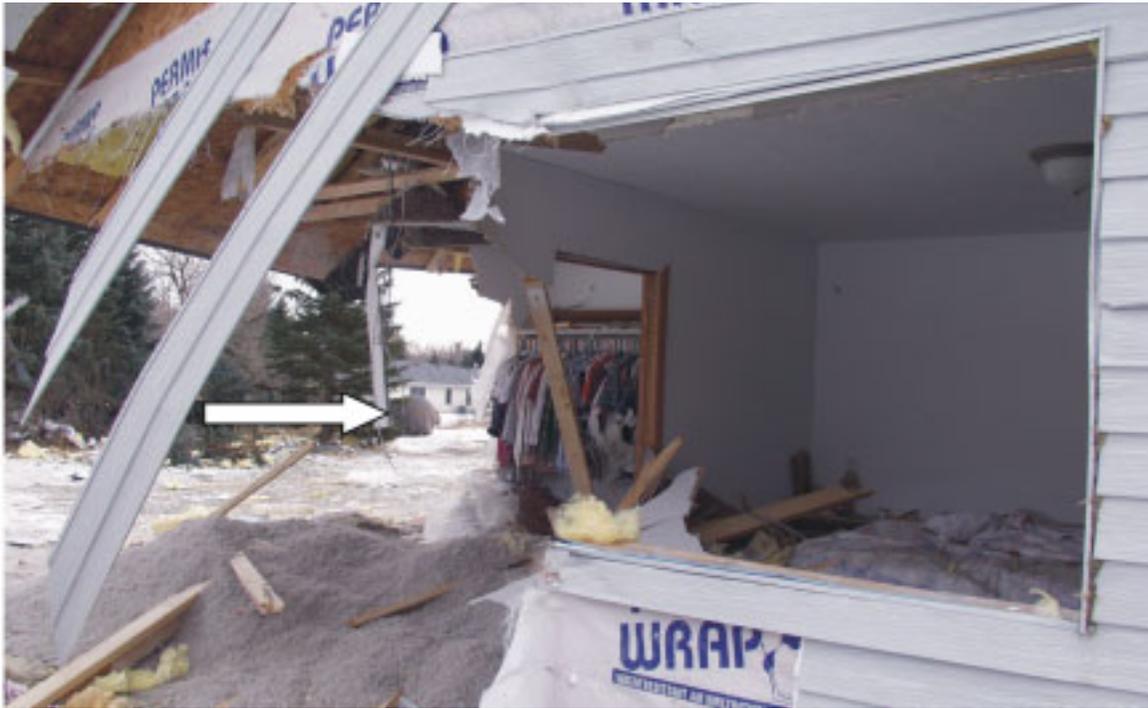
As a result of the derailment, two houses in the Tierracita Vallejo neighborhood were damaged. One section of tank car GATX 47982 (car 22) was propelled approximately 1/4 mile east of the derailment, crashing into a room in which two people were sleeping. (See figure 6.) The second house damaged was the one struck by the truck in which two residents were attempting to leave the area. (See figure 7.)

Figure 6. One section of tank car GATX 47982 (car 22), indicated by the arrow, was propelled approximately 1/4 mile east of the derailment, crashing into a room in which two people were sleeping.

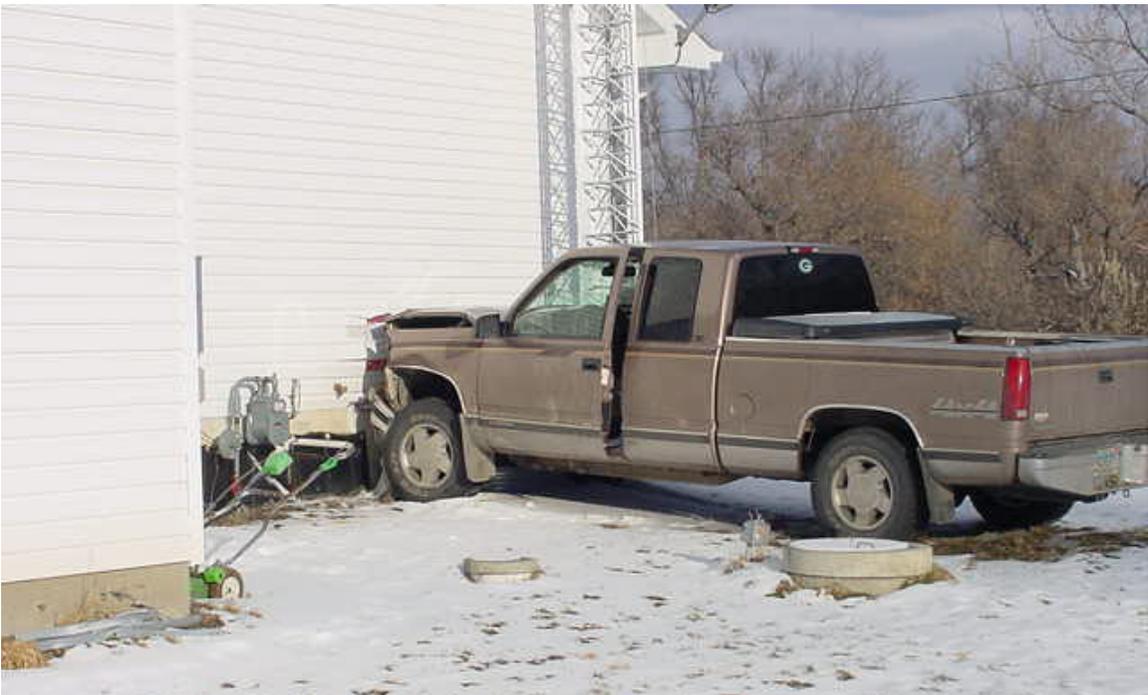
Figure 7. House struck by truck in which two residents attempted to leave the area.

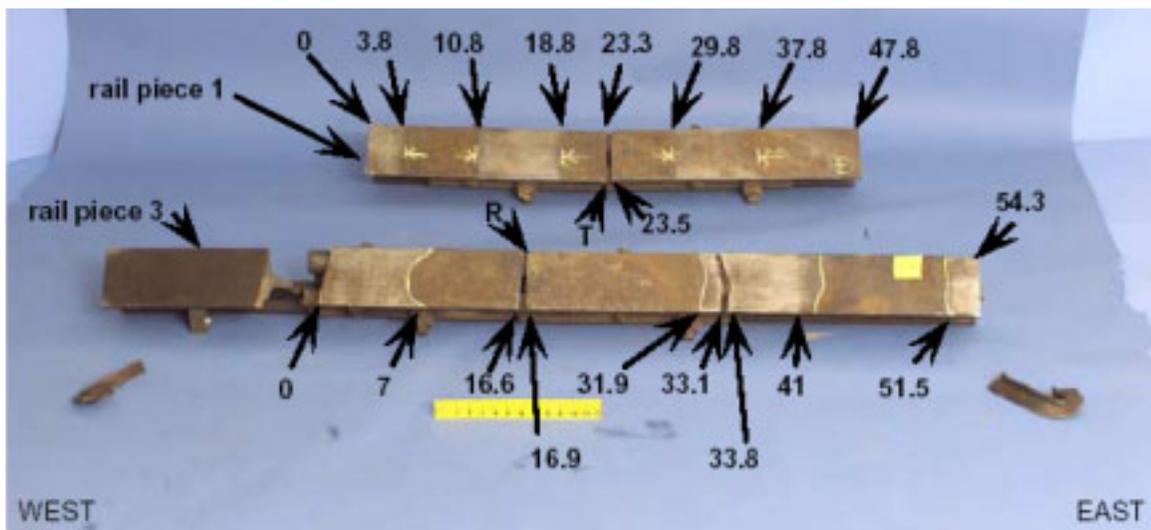
A method of determining whether rail has moved is by examining the contact point between the rail and the tie plate. (See figure 9.) The underside of the rail is shiny at this point because of the abrasive action that occurs where the rail rests on the tie plate. If the track has moved longitudinally, the shiny area is wider than the width of the tie plate. The shiny areas were measured on the rail that fractured at the east joint of the plug, and the tie plates that contacted the rail were also measured. The shiny areas on the rail were 8 inches wide, and the tie plates were 7 3/4 inches wide.

Figure 9. Underside of the recovered pieces of rail from the north side of the track. Pieces placed as they were before they were fractured. The numbers indicate the distance in inches from the “0” arrows.

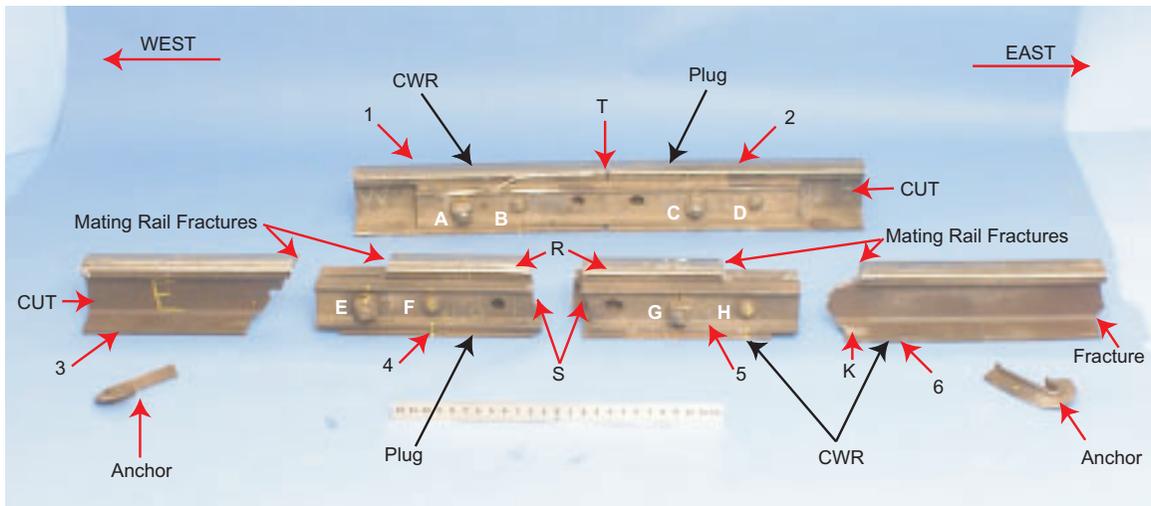
plug. Rail pieces 2, 3, and 4 were from the 36-foot plug installed in May 2000. Rail piece 4 was the easternmost piece of the plug, and the fracture on the west end of this piece matched the fracture on the east end of piece 3. Rail pieces 5 and 6 were from the CWR on the east side of the plug, and a portion of the fracture on the east end of piece 5 matched a portion of the fracture on the west end of piece 6. As shown in figure 10, the joint bars at the east end of the plug were fractured between pieces 4 and 5. The joint bars at the west end of the plug (between pieces 1 and 2) were intact.

Figure 10. Recovered pieces of rail and joint bars from the north side of the track. Arrows “S” indicate the location of the fracture on the pair of joint bars from the east end of the rail plug. Arrows “R” indicate the joint between rail pieces 4 and 5. Arrow “T” indicates the joint between rail pieces 1 and 2.

Rail piece 4, the easternmost piece of plug rail, exhibited a mark on the top of the rail, an impact mark on the fractured end of the joint bar, and an impact mark on a track bolt identified as bolt G on the gage side.

As shown in figure 10, the joint bars from the west joint of the plug were bent but not broken, and were received in the laboratory still attached to pieces of rail. Visual, ultrasonic inspection, and dye penetrant inspection of these bars did not reveal any cracks.

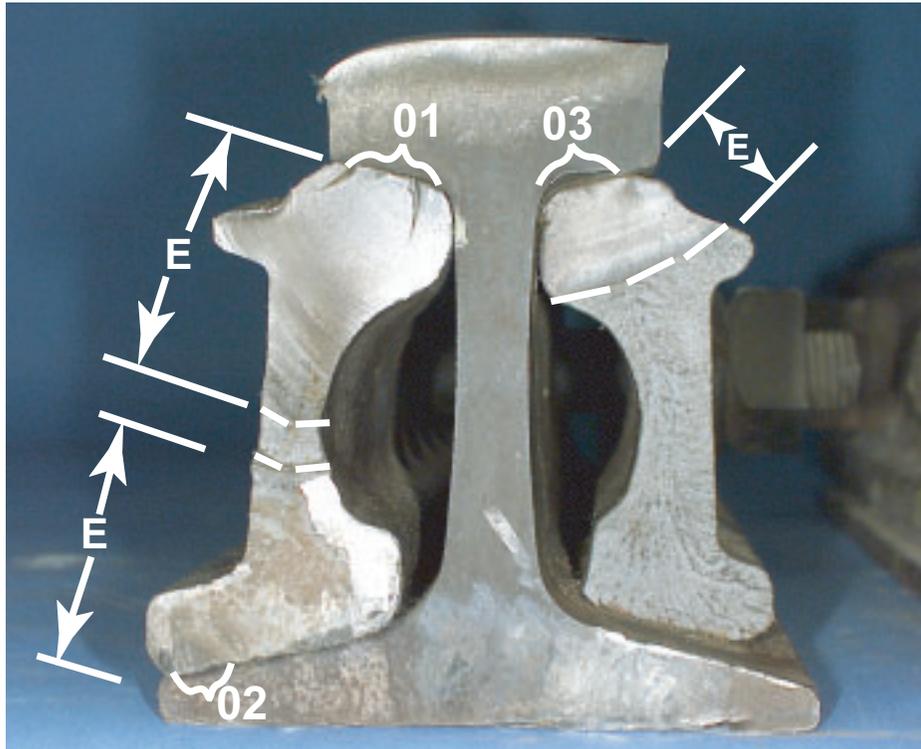
Figure 11 depicts the fracture faces of the joint bars. The joint bar on the gage side contained a 2.1-inch fatigue crack that originated from the top of the bar in the area marked “01,” extended downward through a portion of the web, and terminated in the area indicated by the dashed line. This fatigue crack was externally visible (not obstructed by the rail) over a length of 1.9 inches. The same joint bar contained another fatigue crack that emanated from the bottom of the bar in the area marked “02.” This fatigue crack propagated into the web portion and terminated at the web area indicated by a dashed line. The length of this fatigue crack was approximately 1.9 inches. This fatigue crack was externally visible (not obstructed by the rail) over a length of about 2 inches (when measured along the exterior surface contour). The area between the two fatigue regions showed features of overstress separation. The field side joint bar had a fatigue crack that emanated from the top of the bar in the area marked “03.” This fatigue crack propagated

approximately 0.9 inch into the web portion to the area indicated by a dashed line. This fatigue crack was externally visible (not obstructed by the rail) over a length of 0.8 inch. The remaining portion of the joint bar showed features of overstress separation. Visual examination did not reveal any other cracks in the east joint bars.

Figure 11. West faces of the fractured joint bars showing fatigue origins 01, 02, and 03. The gage side is on the left. Area between arrows “E” indicates portion of a fatigue crack that was exposed to the exterior surface.

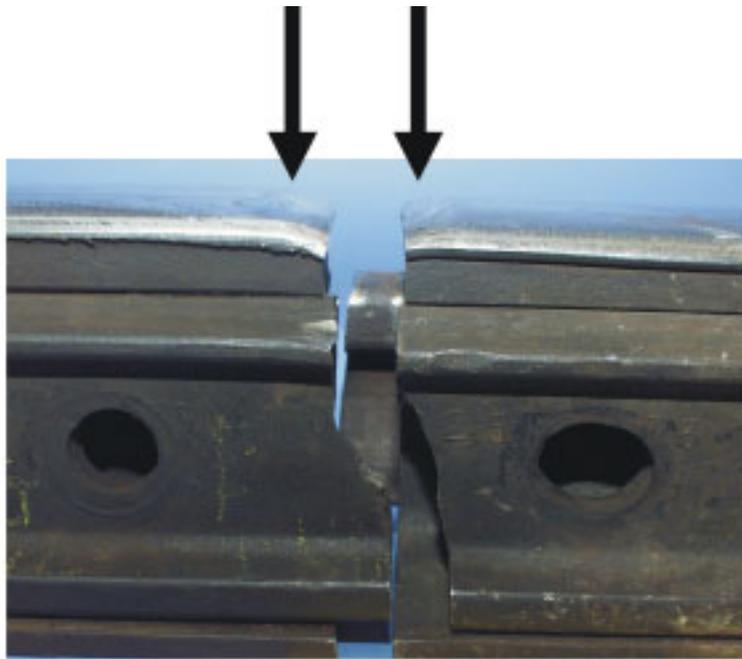
Rail End Batter. The rail end batter was measured⁴¹ for each end of each rail piece described above and pictured in figure 10. Seven ends of rail (pieces 3, 4, 5, and 6) contained rail head deformation adjacent to the cut or broken ends, with the most severe deformation on the butt ends at the east joint. (See figure 12.) No such deformation was noted on pieces 1 or 2. The head on the east end of rail piece 4 (the east end of the plug) was deformed in a manner consistent with trailing rail end deformation.⁴² The depth (distance deformed downward) at this location was 0.22 inch. The head of the west end of rail piece 5 (the CWR at the other end of the east joint) was deformed in a manner consistent with receiving rail end deformation.⁴³ The depth of the receiving rail end deformation for piece 5 was 0.19 inch. The length of both the trailing and the receiving rail end deformation at the east joint butt ends measured 0.75 inch.

Figure 12. Batter on the accident rail.

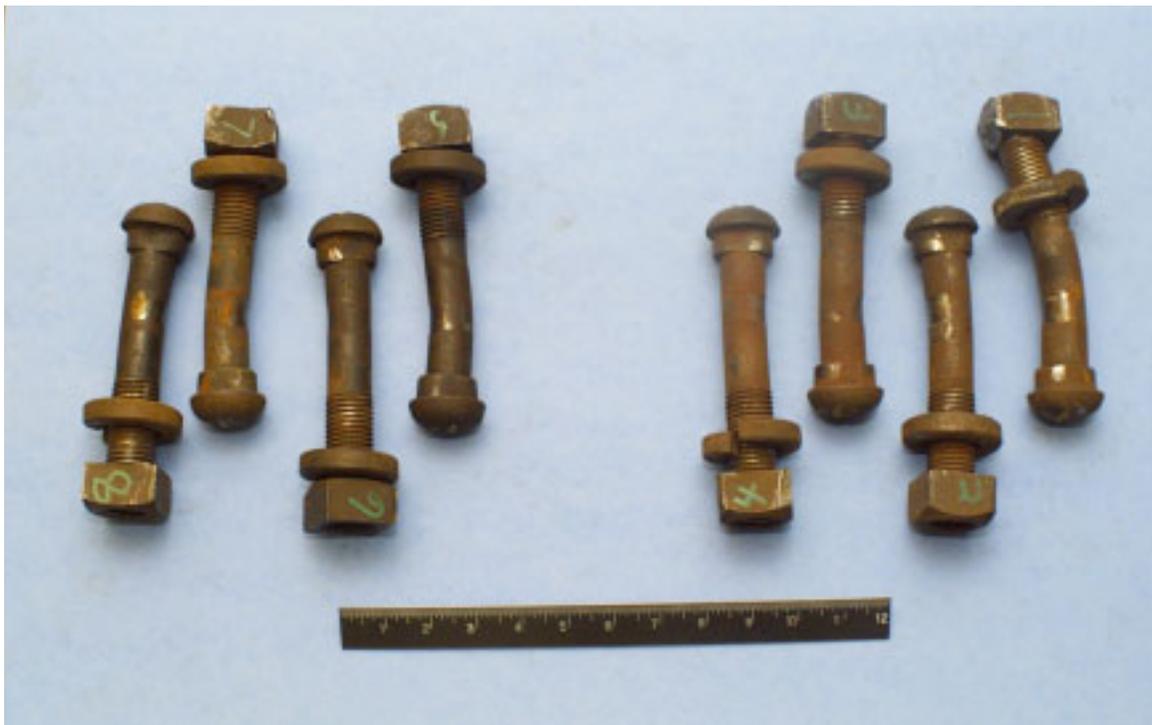
Bolt Condition. The eight bolts from the west and east joints were removed and are shown in figure 13. The bolts were inserted into the joint bars alternately from the outside and from the inside. The shank portion of each bolt contained double bending deformation.⁴⁴ The bending deformation on each bolt was oriented away from the butt end of the rail joint. This bending deformation is consistent with tensile loading⁴⁵ of the rail. The diameter of the shank portion of each bolt in areas that contained no evidence of deformation measured between 0.98 and 1.01 inch, consistent with a 1-inch nominal diameter bolt.

Figure 13. The eight bolts that fastened the joint bars. The disassembled bolts, washers, and nuts are positioned as they were when in place. Note that the shank portion of the bolts are bent away from their rail joints.

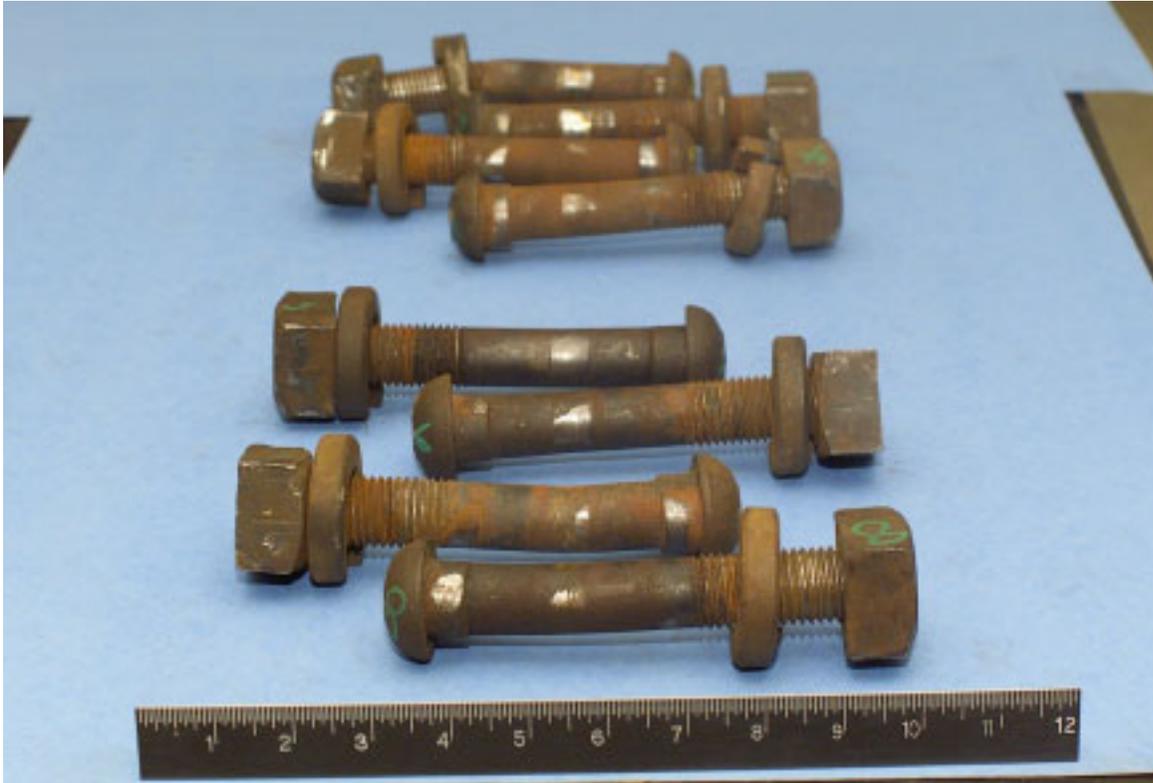
The shank portion of each bolt also contained fretting⁴⁶ damage that corresponded to contact from the web portion of the rail. (See figure 14.) Fretting damage was most severe on the side of the bolt that was nearest the joint. Fretting damage on the diametrically opposite side of the bolts was minor. Additionally, the neck portion of all the

bolts and the shank portion of the bolts that contacted the holes of the joint bars showed fretting damage all around the bolts.

Figure 14. The shiny areas indicate fretting damage on the bolts that fastened the accident joint bars.

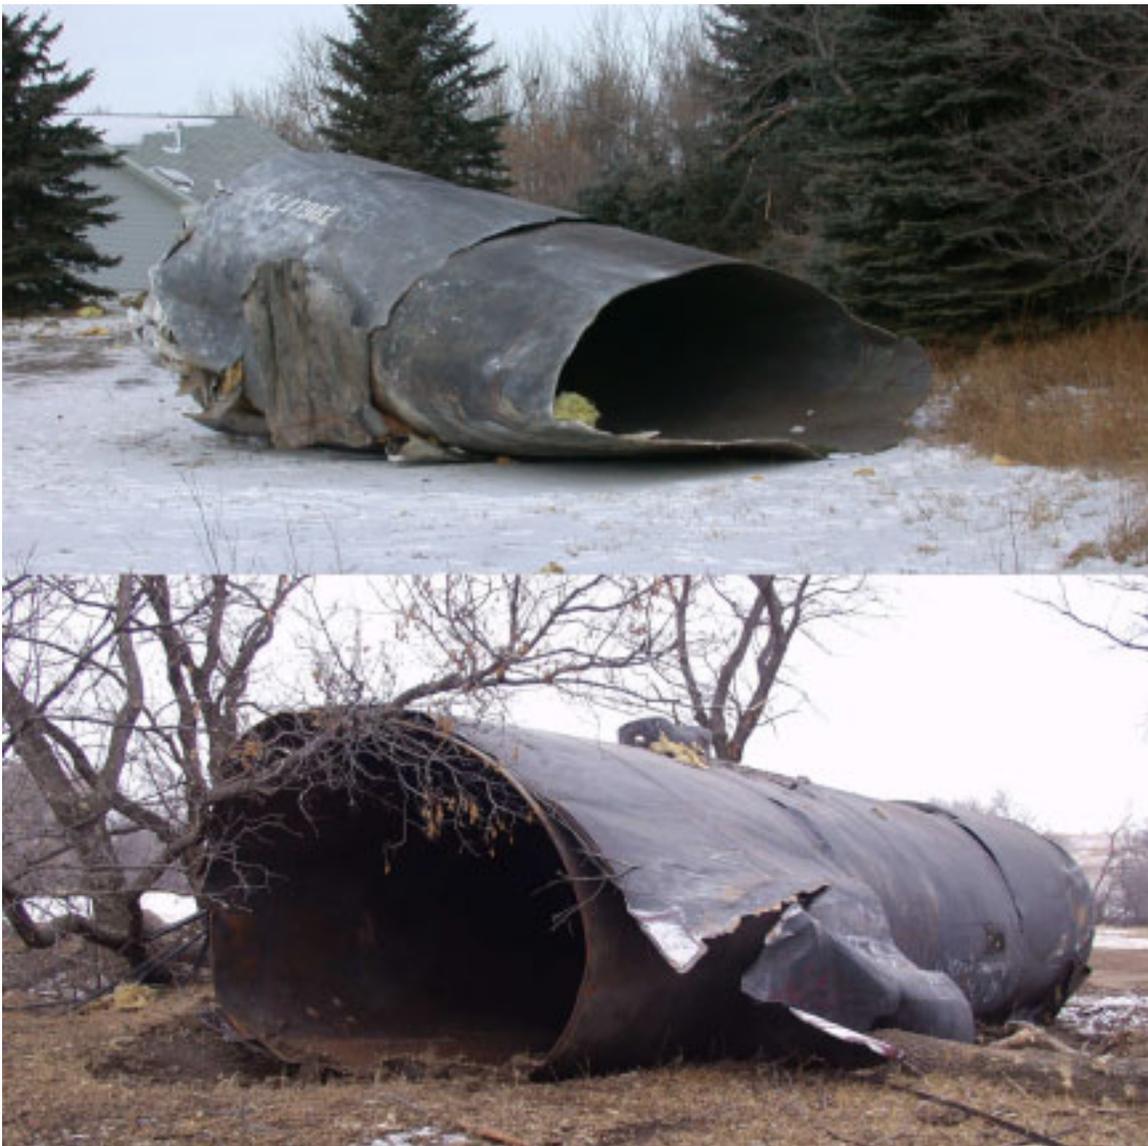
During the derailment, the first seven of the derailed anhydrous ammonia tank cars rotated laterally and separated from their couplers and came to rest aligned perpendicular to the tracks. Five of these tank cars received sidewall impacts to their shells, and the shells structurally failed. Four of these tank car shells sustained fractures that propagated completely around their circumferences. (See figure 15.) The fifth tank car, GATX 47837

(car 20), sustained a fracture that propagated partially around the shell and through the head, resulting in the separation of the tank head from the tank car. Metallurgical examinations showed that the head contained a ductile fracture that propagated from a brittle fracture in the shell portion. Also, within this group of seven severely damaged tank cars, two tank cars, PLMX 4644 (car 18) and GATX 49248 (car 21), received localized shell punctures from derailling debris; however, these punctures were contained in the immediate area of impact, and the cracks did not grow farther into the shells. As a result, these shells partially retained their contents after derailling. However, they vented ammonia at atmospheric pressure for several days, eventually losing all their contents.

Figure 15. GATX 47814 (car 19), above, and GATX 47982 (car 22), below, sustained catastrophic shell fractures. Car 22 hit the house visible behind and to the left.

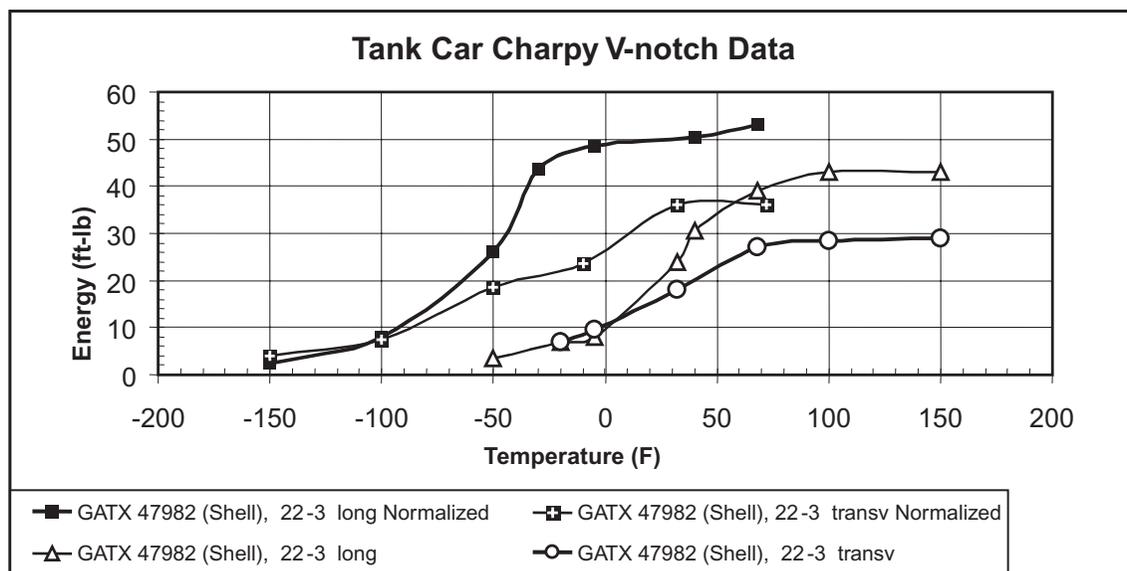
Figure 16. Ductile-to-brittle transition temperature curves generated by Charpy V-notch tests for a shell sample that was removed from tank car GATX 47982.

Assuming that the tank car shell was at a temperature of approximately 36° F at the time of the accident, the “22-3 long” curve shows that the impact energy associated with a crack propagating along the length of the shell is 28 ft-lbs, and the “22-3 transv” curve shows that the impact energy associated with a crack propagating around the shell is 20 ft-lbs. The curves also show that, at 36° F, the normalized specimens fracture in a ductile manner with a significant increase in the impact energy, up to nearly 50 ft-lbs for a longitudinal specimen and 36 ft-lbs for a transverse specimen.
